**Piuraagvik Recreation Center
2022 Structural and Mechanical Inspection**

Prepared for City of Utqiagvik

Project # 165.030530

**Mechanical Inspection Services
Final Report**

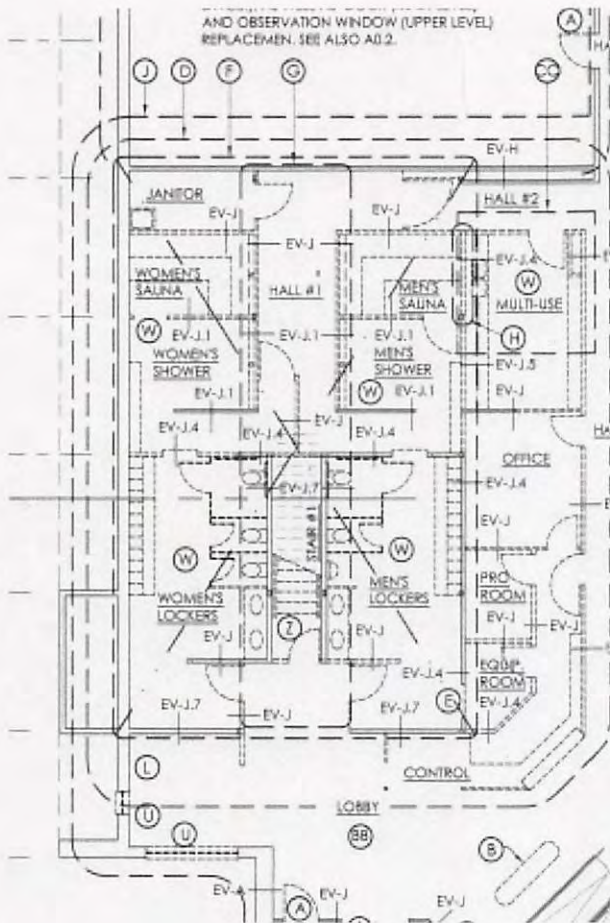
Piuraagvik Recreation Center was constructed in 1984 and phase 1 modernization occurring in 2011-2012. The original bathroom and locker rooms were resituated when the remodel occurred (See figures 1-2). When the remodel occurred, the majority of the area was remodeled, and new fixtures and waste drains were installed. New men's and women's saunas were also installed in each separate locker room.

Figure 1. Historic construction

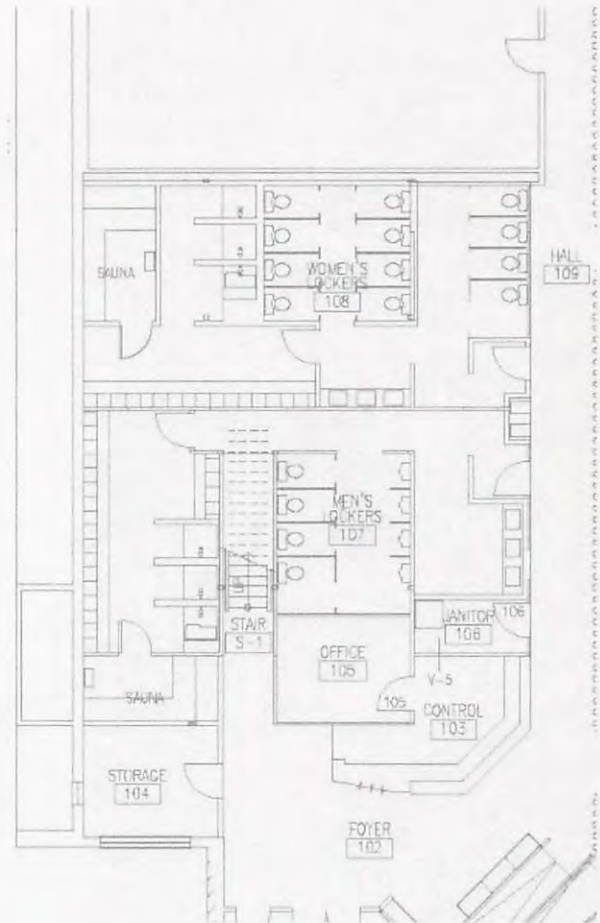
Figure 2. 2011-2012 Remodeled Bathrooms and Sauna.

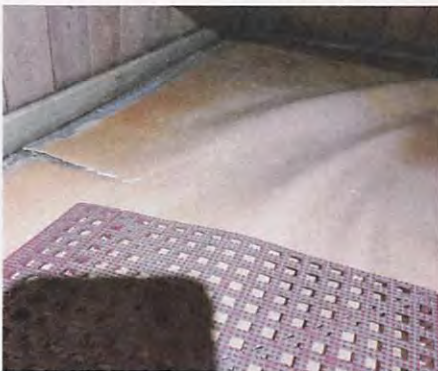
- Weight room:
 - Minor damage to the Racquetball Court surface. See attached appendix for more detail in the structural report.
- Women's Locker Room:
 - Significant damage was found, specifically beneath the women's sauna. This is due to a combination improper flooring being used and therefore delaminating from excessive heat and moisture causing bubbling and cracking. Excessive amounts of water being used on the Sauna rocks and poor drainage/floor slope lead to damage of the sub-floor (See photos 1-3). See attached appendix for more detail in the structural report.

Photo 1. Damage to sauna floor.

2. When replacing sauna, it should be constructed from the appropriate material that will be able to handle high heat and humidity. The floor, walls, and ceiling should have a vapor barrier according to standard sauna construction. The floor should be sloped to drain and the floor drain should be placed appropriately. If the drain is placed where it is likely to come in contact with the persons, necessary flooring is to be installed to prevent burns and allow proper drainage.

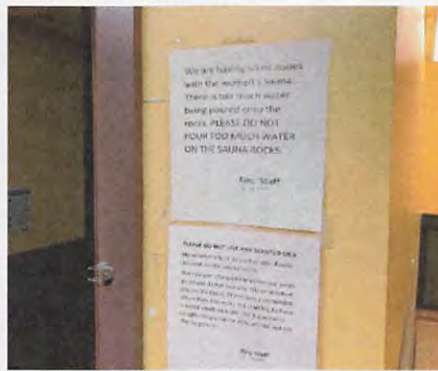
Photo 2. Notice of flooding.

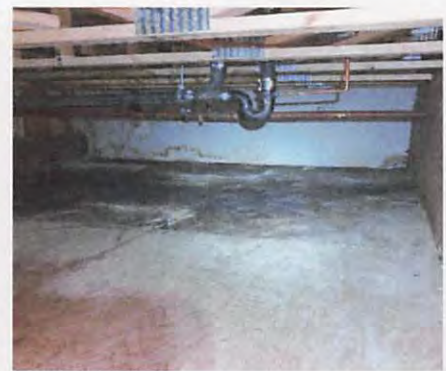
Photo 3. Beneath women's sauna.

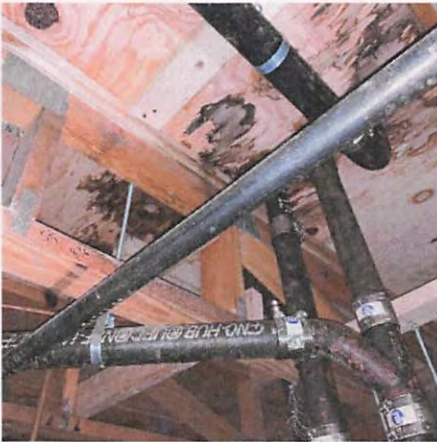
- In general, the majority of the sub-floor around the floor drains were overcut and the flange installed did not create a watertight seal leading to damage (See photos 4-6).

Photo 4. Damage around drains.

1. Replace flooring in bathrooms. See incorporated appendix, structural report for more detail. When flooring is replaced, ensure watertight seals around fixtures and drains. Ensure that cutouts in floor are sized properly. Ensure that drain flanges are installed correctly, flush with flooring to allow proper drainage from flooding and cleaning.

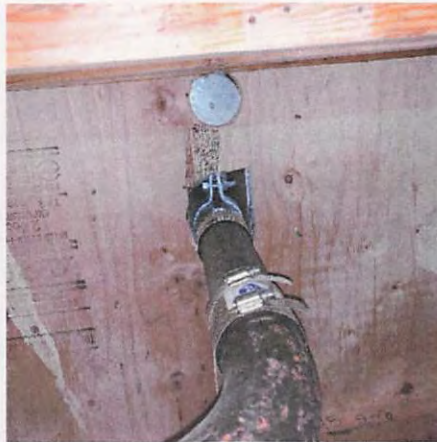
Photo 5. Cutout too large for drain.

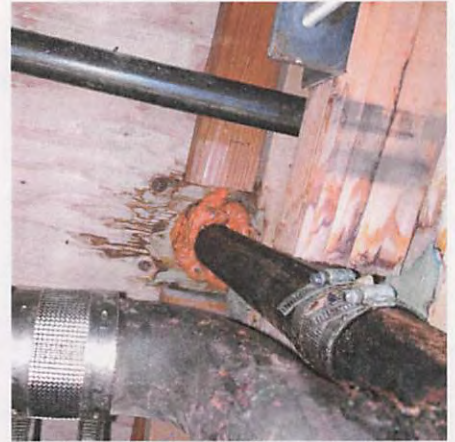
Photo 6. Damage around drain.

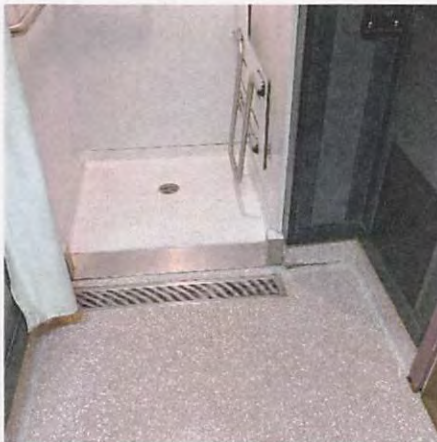
- Floor finish has reached the end of their service. See attached appendix for more detail in the structural report (See photos 7-8).
 - Showers in the locker room were labeled out of order (See photo 9).

Photo 7. Shower area floor damage.

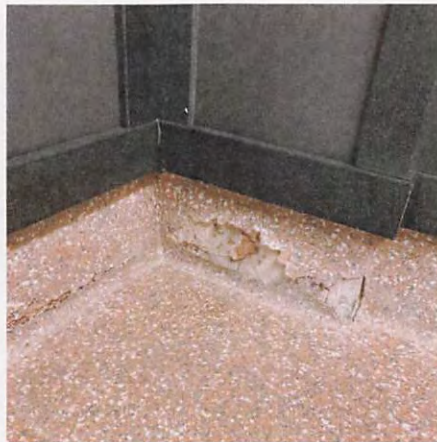
Photo 8. Shower area floor damage.

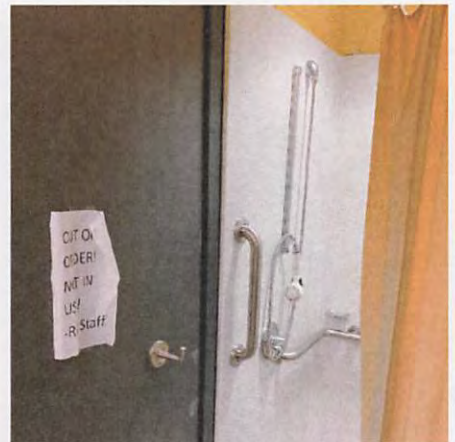
Photo 9. Notice of out of order shower.

3. Replace all relief valves and specific elbows and couplings where leaks are visible to have occurred.
4. Replace showers as necessary.
5. Assess damaged upstairs CUH unit to see if needs replacing.

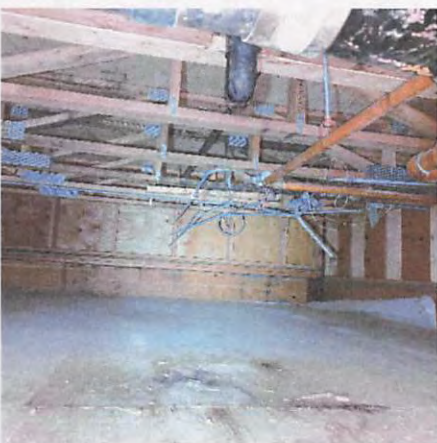
- Multiple leaking pressure relief valves. See photos 10-14.
 - Leaking elbow joints. See photo 15.
 - Leaking coupling joints. See photo 16.
 - Leaking in mechanical room. See photo 19.

Photo 10. Damage under drain.

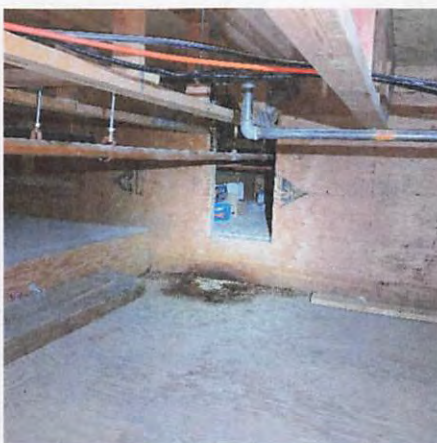
Photo 11. Damage under relief valve.

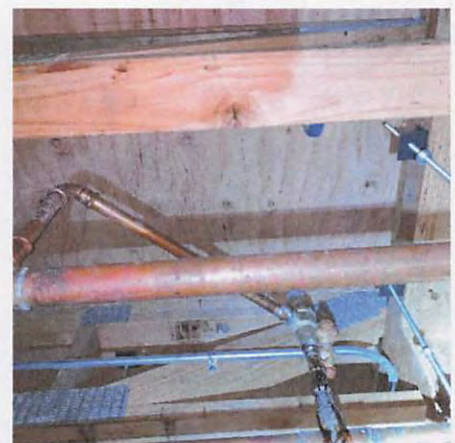
Photo 12. Relief valve.

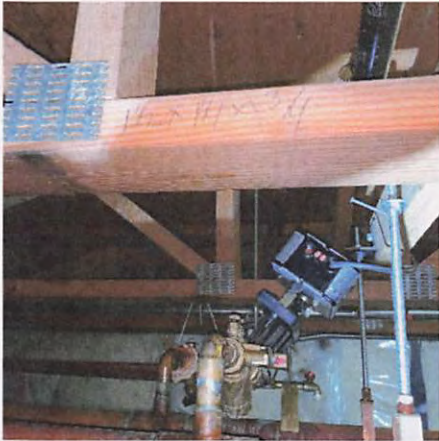
Photo 13. Relief valve.

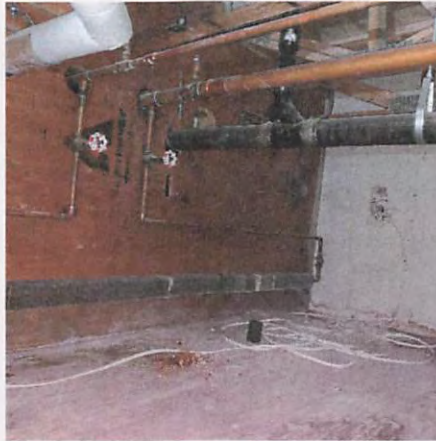
Photo 14. Damage under relief valve.

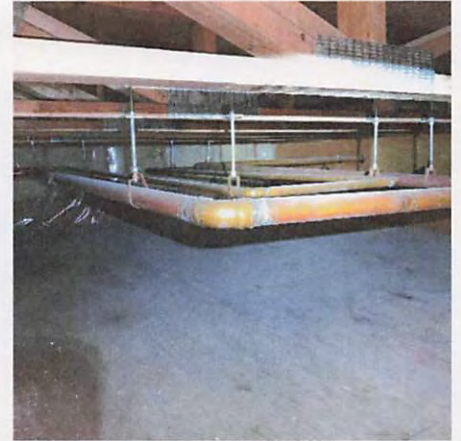
Photo 15. Stain under elbows.

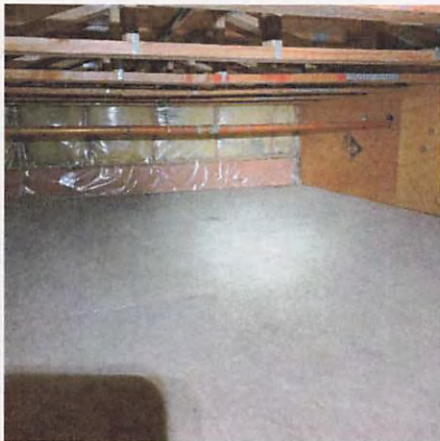
Photo 16. Leak under coupling joint.

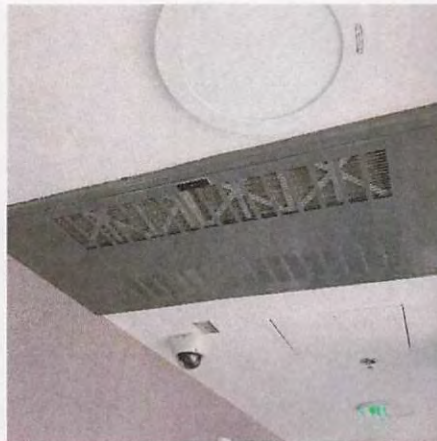
- Leaking in air heating room. See photo 20.
- CUH-1 unit could be seen with visible dried leaks. See photos 17-18.
 - It was mentioned by maintenance that the leak is formed during the winter when snow is on the roof but stops when the snow is removed.

Photo 17. Leaking CUH-1.

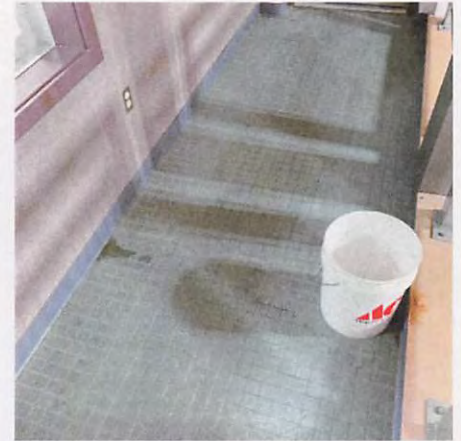
Photo 18. Area beneath CUH.

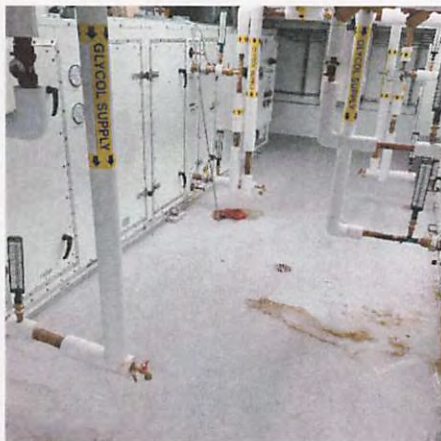
Photo 19. Air heating room.

6. Assess glycol loop in mechanical room and air heating unit room to determine if repairs are necessary and cost effective.

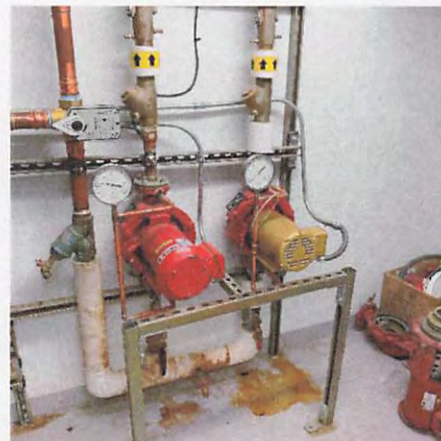
Photo 20. Mechanical room glycol supply loop.
