Piuraagvik Recreation Center Utqiagvik, Alaska

Structural Inspection Services Final Report

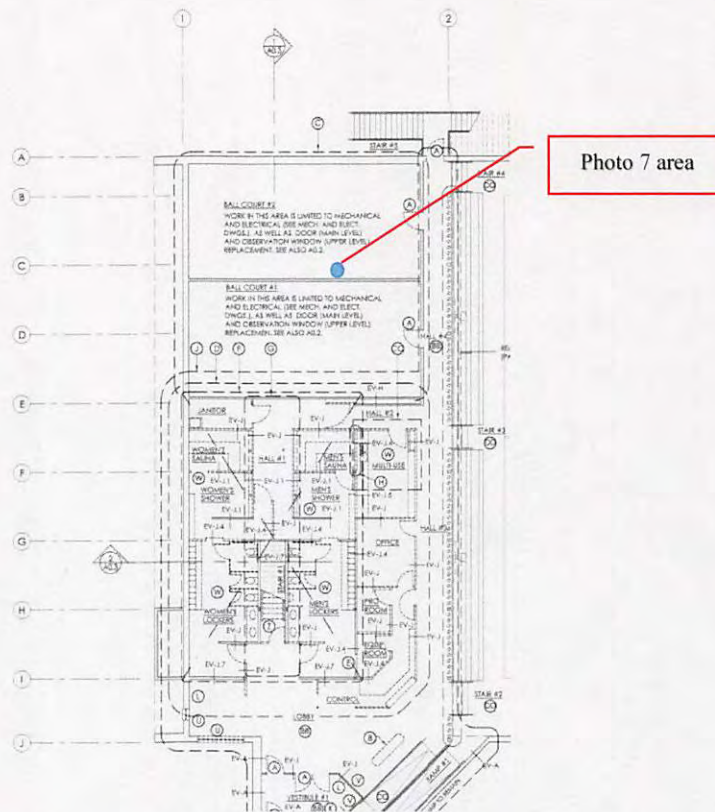
Figure 1: Facility Layout snip from 2011 BDS Drawings

The main floor construction of the facility between Grids 1 and 2 is comprised of 14" deep, top chord bearing manufactured trusses with a 23/32 tongue and groove subflooring, see photo 1. Trusses are spaced at 2'-0" on center and span 12'-0" between Grids B and J, reference Figure 1. Architectural floors were constructed above the subflooring based on the intended usage. A soffit floor was present below the trusses in this area provided a crawlspace area for plumbing, electrical and storage. The soffit floor assembly was not determined as part of this visit.

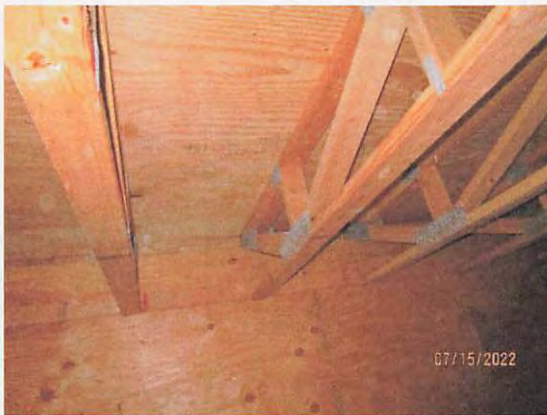
Photo 1: Truss configuration from centerline

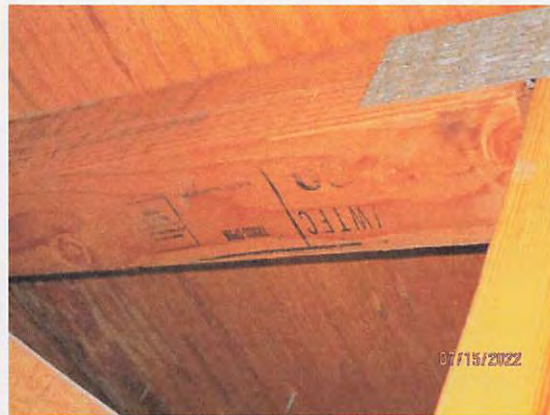
The only markings found on the main floor trusses identified them as Truss-Span from Auburn, Washington and being constructed in accordance with UBC Standards, see photo 2. This company is no longer in business and calls to other major floor truss manufacturers resulted in no information being available as to original load tables.

Photo 2: Truss marking

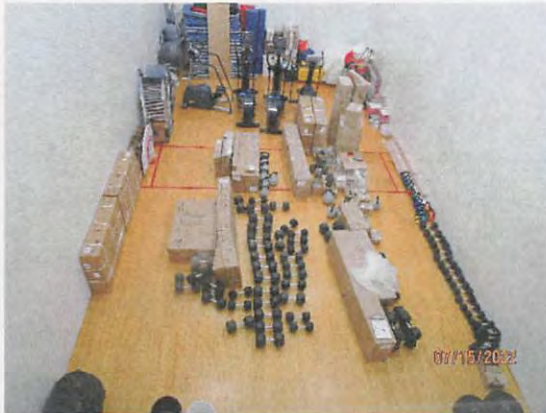
The structural flooring under the original ball courts do not show visual signs of distress. The architectural flooring is visually distressed due to the current loading and has been damaged by a dropped weight (photos 3 through 6). Significant damage within the weight room is limited to a 9" x 20" area; however, the unloaded bench press seen in photo 4 is on mats to keep it level as the hardwood flooring is visibly deflected. Photo 7 shows the underside of the ball court flooring, clarifying the construction as being 1/4" thick hardwood over 2x4 spacers on rubber pads. Based on the nailing pattern in the flooring itself, it appears that the 2x4 spacers are located approximately 13" on center. Currently, the equipment bearing directly on the hardwood flooring is causing visible deflections that will eventually lead to further material breakage.

Photo 3: Ball Court 2 / Storage Overview

It is recommended that the architectural flooring assemblies in both of the ball courts be removed to the subfloor plywood and replaced with appropriate flooring, likely weight room style mats capable of properly supporting the weight room equipment and stored materials. Any areas of missing subflooring, as seen in photo 7, shall be repaired to restore floor live load capacity.

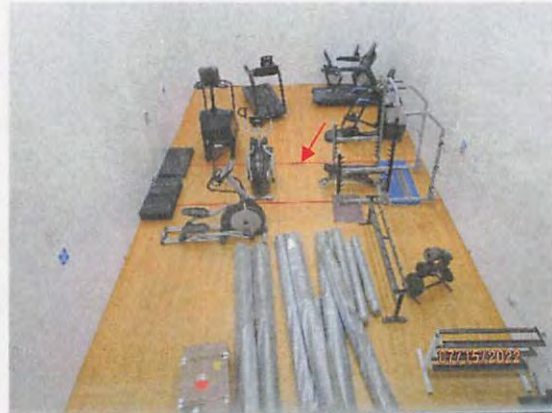
Photo 4: Ball Court 1 / Weight Room Overview
(Note: arrow points to damaged area)

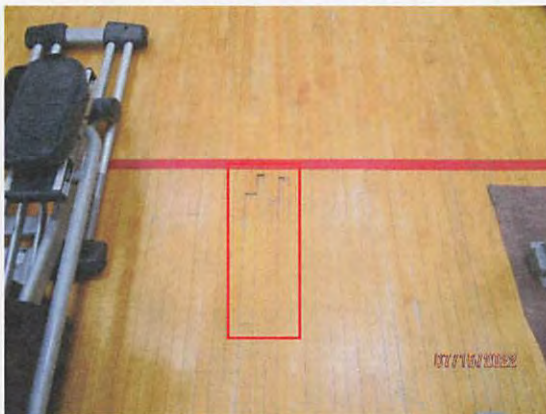
Photo 5: Weight room flooring damage
(Note: box outlines damaged area)

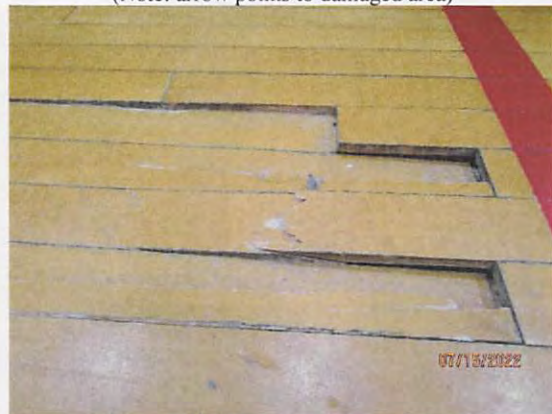
Photo 6: Weight room flooring damage

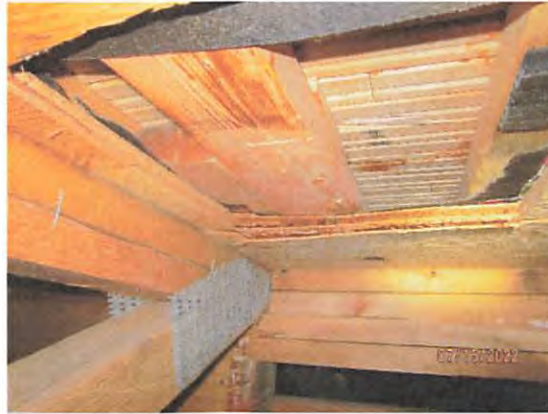
Photo 7: Ball court flooring construction

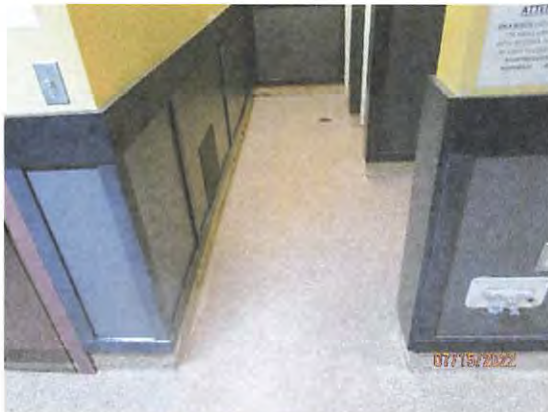
This locker room includes the women's shower, toilet facilities, lockers, and sauna. Showers, lockers, and sauna are located behind a separate door that can be closed and secured to prevent access. Floor finishes have reached the end of their service life and damage was noted at most corners and around drains. Within the shower, locker room and sauna area, the flooring is visibly sloped and spongy away from drain areas. Restroom, shower, and locker room flooring appears to be a poured epoxy system. Sauna flooring appears to be an adhesive style vinyl that has bubbled in several areas due to the heat and humidity of a sauna, followed by excessive amounts of water being used on the rocks (see photos 8-11). No active leaks were found during the investigation.

Photo 8: Corner damage

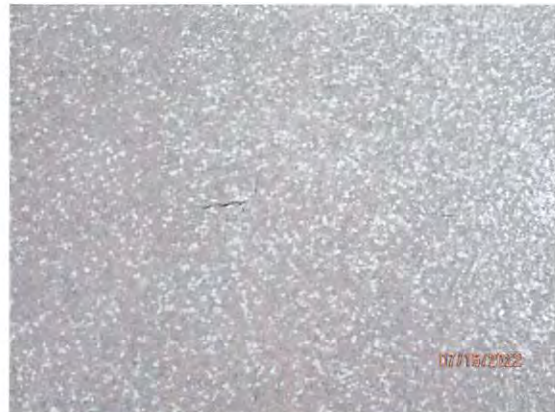
Photo 9: Cracked finish near shower entry

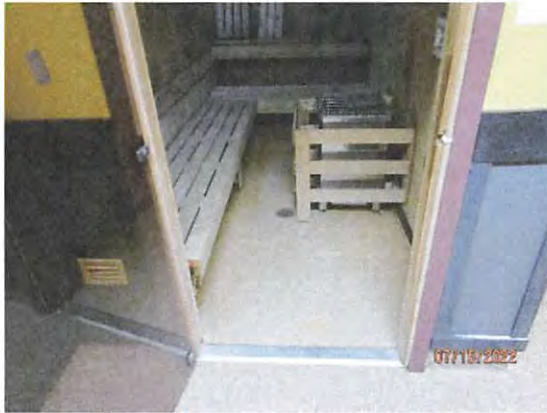
Photo 10: Women's sauna flooring

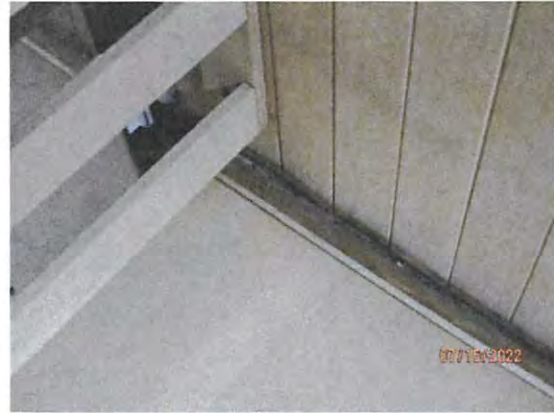
Photo 11: Women's sauna flooring at wall

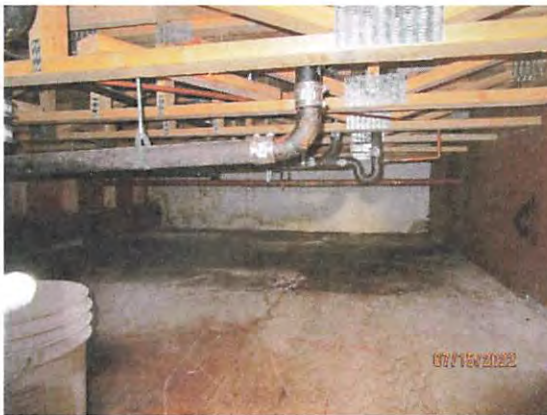
Review of the flooring construction within the crawlspace area showed significant water damage that has occurred either from original construction or when phase 1 repairs were completed. Four trusses between the exterior wall and edge of the locker area also showed signs of water damage and did not appear to have been replaced as part of the phase 1 repairs. It is expected that the top chords have significant rot present where contacting the floor sheathing that will not be fully uncovered until the sheathing has been removed. These trusses could remain in place if top chord deterioration is not found during demolition. The soffit sheathing itself showed water staining, both on the interior and exterior of the structure (see photos 12 to 17).

Photo 12: Crawlspace area under women's shower & sauna

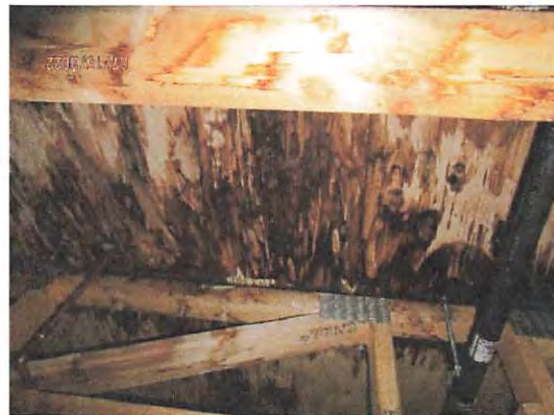
Photo 13: Underside of sub-floor at women's sauna
