TRIDENT ENGINEERING AND INSPECTION

Piuraagvik Final Report

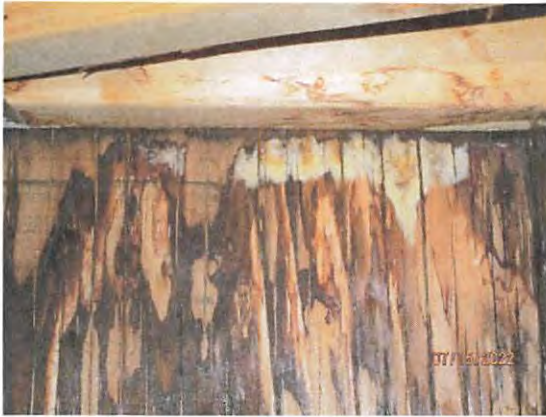
Photo 14: Mold growth on subflooring

It is recommended to close the women's locker, shower, and sauna area to the public until appropriate flooring repairs can be completed. There is a chance that portions of the flooring can give way, and someone could partially fall through the floor and into the crawlspace area. There is a minimum of 144 square feet (SF) of subfloor sheathing, 4 primary floor trusses under the areas of significant sheathing damage, 288 SF of soffit sheathing (internal and external), soffit trusses, and soffit insulation with vapor barrier that need to be replaced in this area.

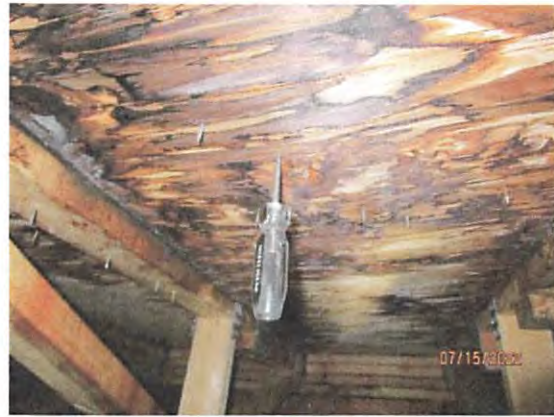
Photo 15: Awl penetration of 3/4" in subflooring

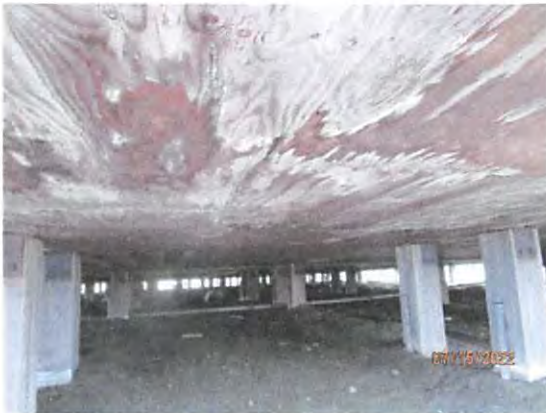
Photo 16: Exterior soffit staining under women's locker area

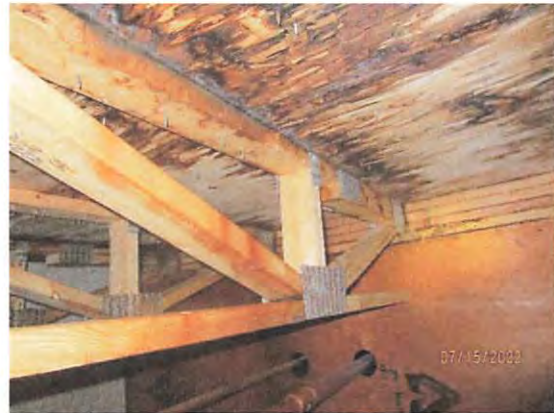
Photo 17: First 3 trusses with water staining

The trusses with water staining were poked in several locations with a scratch awl to determine amount potential damage. All accessible areas tested achieved a maximum penetration of 1/8", equal to areas tested on undamaged trusses nearby.

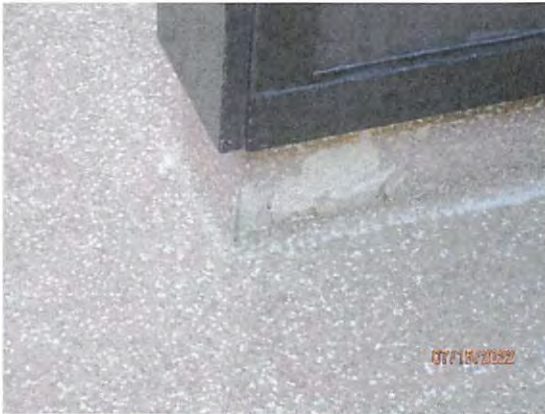
Photo 18: Men's locker flooring damage

It is recommended to repair the finish flooring within the men's locker room and sauna with a more resilient material that can properly withstand water and the sauna heat. Damaged subflooring and overcut holes should be repaired when other repairs are made. Water stained trusses should only be replaced if the top section of the top chord is found to be severely damaged when the subflooring is removed.

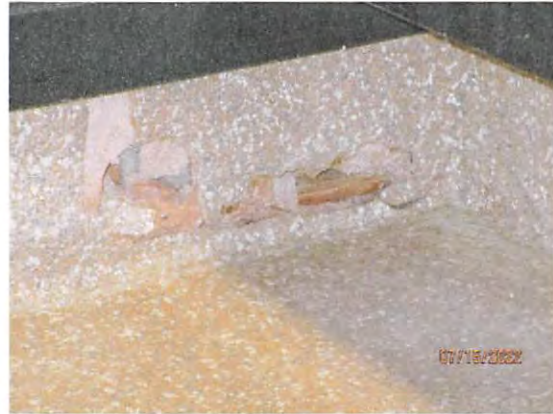
Photo 19: Men's locker flooring damage near sauna

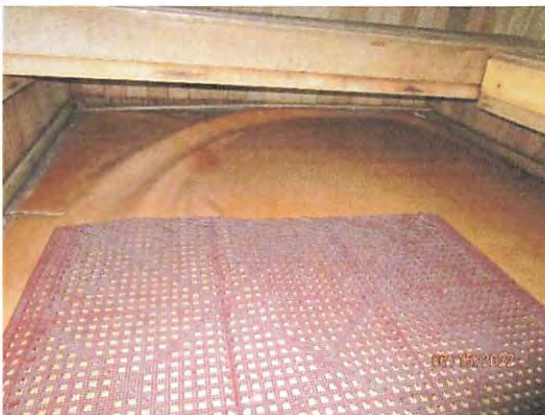
Photo 20: Men's sauna flooring bubbles

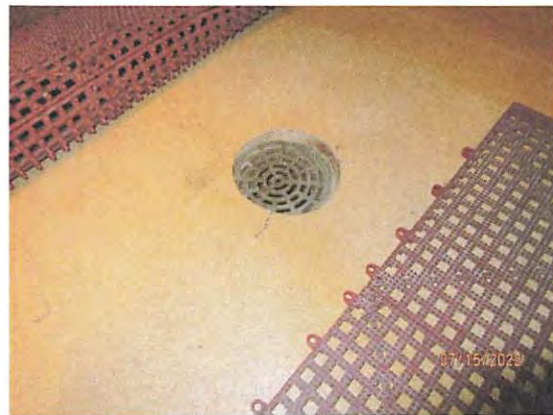
Photo 21: Men's sauna flooring at drain

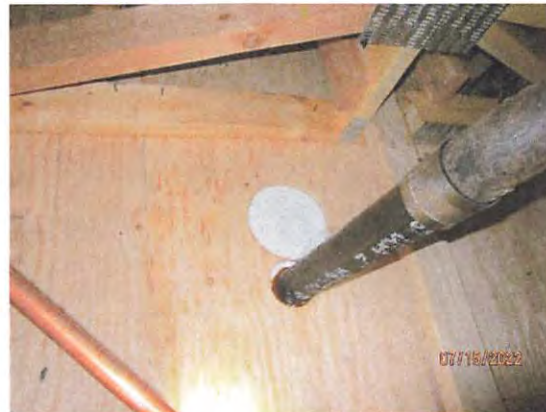
This locker room includes the men's shower, toilet facilities, lockers, and sauna. Similar to the women's area, the showers, lockers, and sauna area are located behind a separate door that can be closed and secured to prevent access. Floor finishes have reached the end of their service life and damage was noted at most corners and around drains. Restroom, shower, and locker room flooring appears to be a poured epoxy system. Sauna flooring appears to be an adhesive style vinyl that has bubbled in several areas due to the heat and humidity of a sauna, followed by excessive amounts of water being used on the rocks (see photos 18-21). One area of soft flooring was found near a drain cleanout in the handicap stall, however, further investigation determined that the subfloor in this area was overcut, and water damage was not present (see photo 22). No active leaks were found during the investigation.

Photo 22: Overcut hole near cleanout.

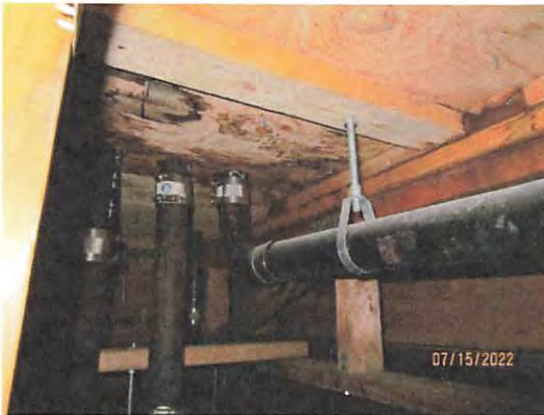
Review of the flooring construction within the crawlspace area showed significant water damage has occurred primarily prior to phase I repairs based on line routing through the floor. Multiple trusses showed signs of water staining, and isolated areas of subfloor sheathing were also stained. These areas were tested with the scratch awl for penetration and found to have a maximum of 1/8" penetration, satisfactory for the age of material. The soffit sheathing itself showed water staining, primarily isolated to the interior of the structure, likely from the original water damage (see photos 23 to 26).

Photo 23: Underside of men's shower area

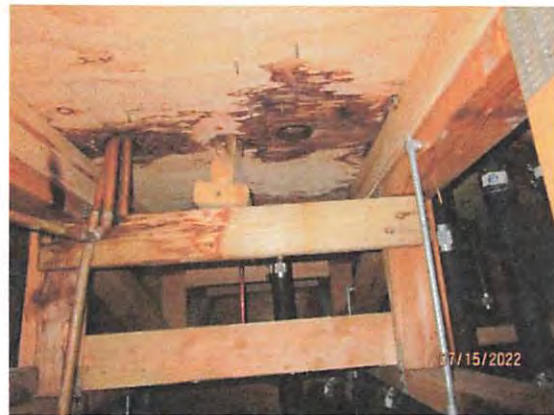
Photo 24: Underside of men's shower area

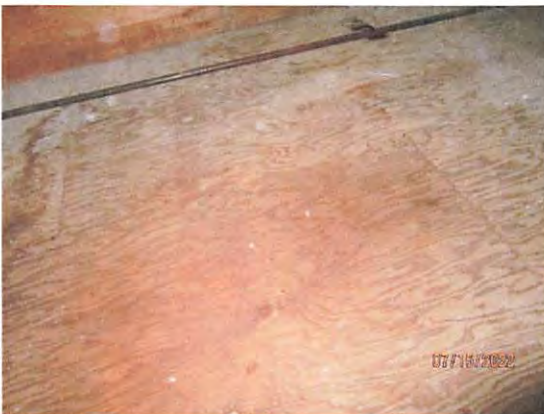
Photo 25: Interior soffit sheathing under men's lockers

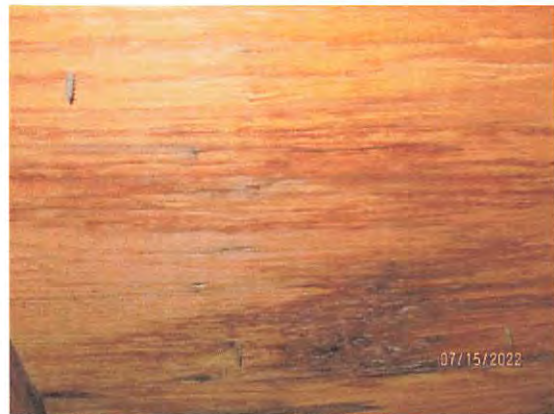
Photo 26: Water staining under men's restroom area

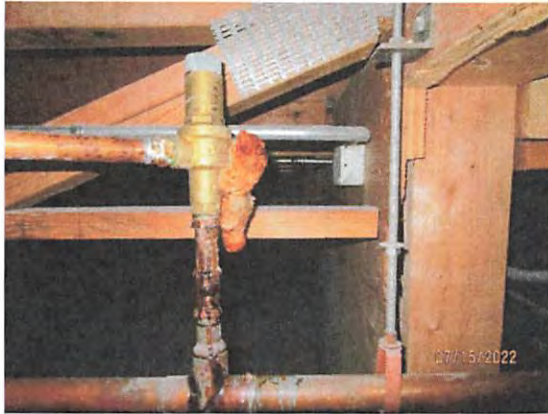
Several non-structural items were noted during the inspection. This included a leaking pressure relief valve in the glycol loop (photo 27), several open electrical junction boxes (photos 28 and 29), an apparent active leak behind the bleachers (photo 30), and an exterior penetration of the soffit framing along the support framing at Grid C2 (photos 31 and 32). The active leak location and the soffit penetration were discussed with facility personnel prior to departure.

Photo 27: Leaking pressure relief in glycol loop

3. Men's locker area – replace the architectural flooring in the entire restroom area, including the sauna. Provide subflooring repairs as necessary.
4. Properly cover the open electrical junction boxes and terminate any abandoned wires.
5. Provide spray foam on the bottom of the soffit at each support penetration to prevent insect or vermin infiltration into the facility.
6. Repair glycol loop in accordance with mechanical engineering recommendations.

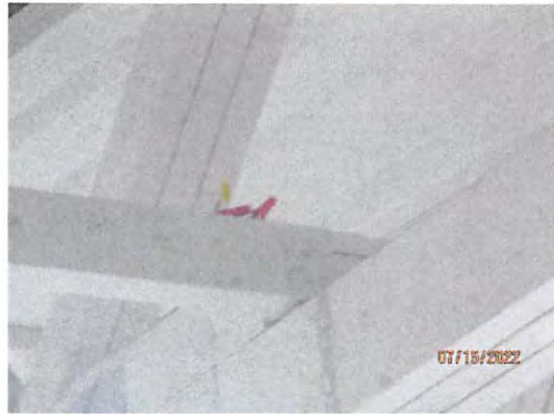
Photo 28: Open junction box in ceiling framing

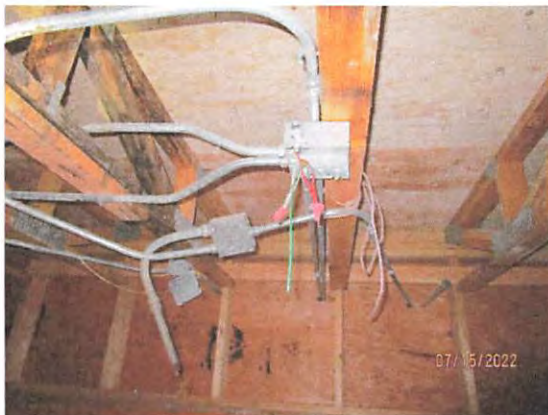
Photo 29: Open junction boxes in crawlspace area

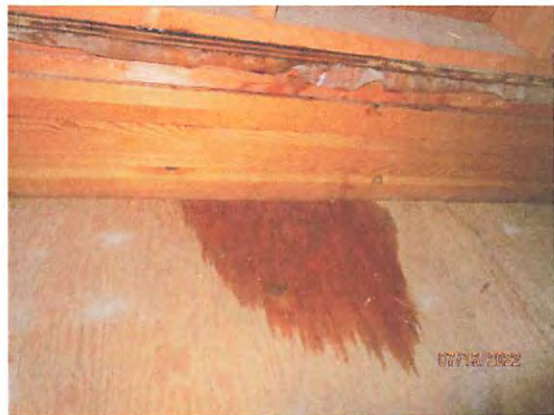
Photo 30: Active wet area behind bleachers

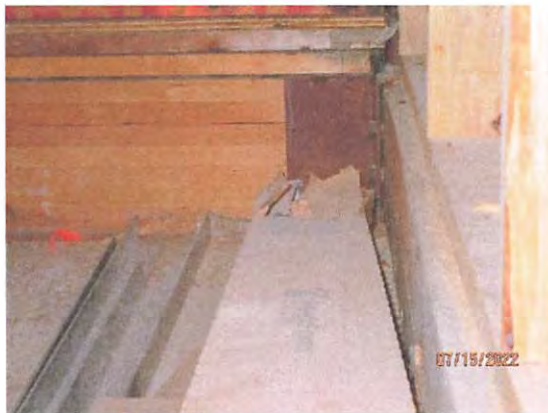
Photo 31: Grid C2 framing - flash on
